Agenda

2014 Four Hour Update

Fleet Condition Notes 2014

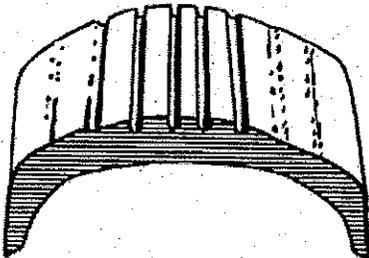
Over Inflation

Excessive wear at the center of the tread indicates that the air pressure in the tire is consistently too high. The tire is riding on the center of the tread and wearing it prematurely. Many times, this visual method of inflation (inflating the tires up until there is no bulge at the bottom) is at fault; tire inflation pressure should always be checked with a reliable tire pressure gauge.

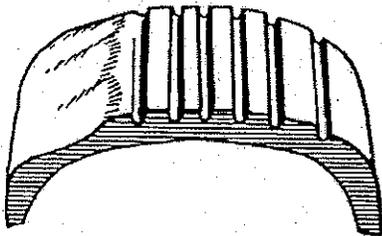
Side Wear

When an inner or outer rib wears faster than the rest of the tire, the need for alignment is indicated. There is excessive camber in the front suspension, causing the wheel to lean too much to the inside or outside and putting too much load on one side of the tire. Misalignment could be due to sagging springs, worn ball joints, worn control arm bushings, or worn king pin bushings.

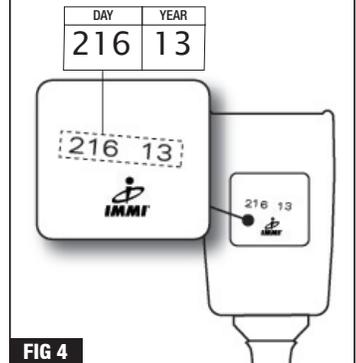
FIG 4

Suspect code range is
214 13 through 256 13

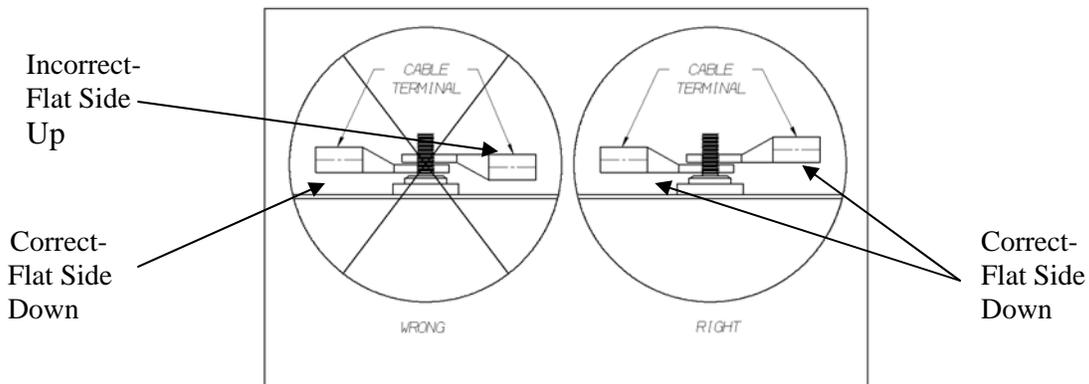
4. Inspect the electrical cable connections at the Power Stud and Aux Power Stud, if installed. See the diagram below to determine if the cables were installed correctly. ALL terminal lugs on each power stud should be oriented such that the barrel of the lug is further away from the mounting surface of the isolated stud. The flat side of terminal end (lug) must be down.

5. If the cables were installed incorrectly, remove the nut securing the cables. Then remove the cables and reinstall correctly per the diagram above. Make sure the terminal lugs are fanned out on the stud as opposed to directly on top of each other. Vice-grip pliers are recommended when turning incorrectly installed cable terminal lug to the correct orientation of flat side down.

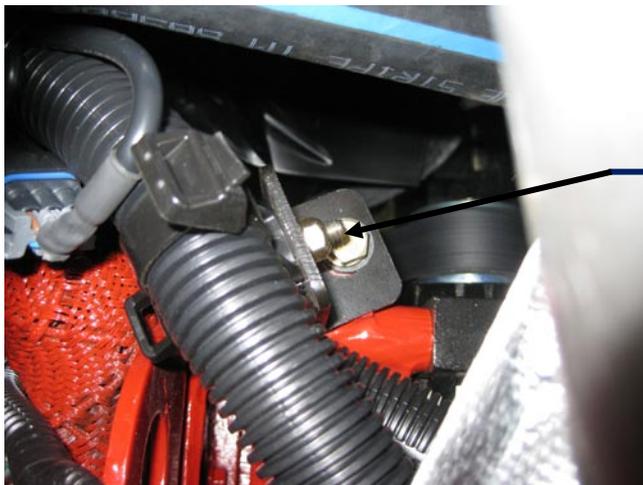
Area of Right side support Bracket, See photo in Step 7

- 6 One starter cable and wiring harness support is located on the right side of the engine between the alternator and engine fan.
- 7 Remove and discard the ¼" serrated nut (and flat washer if installed). Install the new ¼" locknut (0145847) and flat washer (01247709) provided. Torque nut to 60-85 in. lbs. Note: two complete threads must extend completely through the nut.

Replace with new locknut and flat washer (Note: new locknut shown)

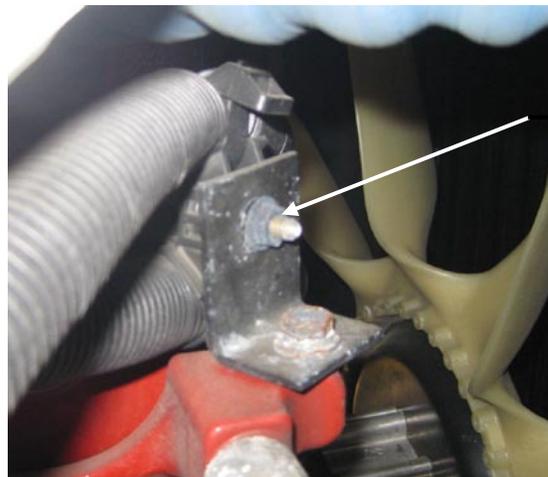
- 4 One starter cable and wiring harness support is located on the right side of the engine between the alternator and engine fan.
5. Remove and discard the 1/4" serrated nut (and flat washer if installed). Install the new 1/4" locknut (0145847) and flat washer (01247709) provided. Torque nut to 60-85 in. lbs. Note: two complete threads must extend completely through the nut.

Replace serrated nut (shown) with new locknut and flat washer

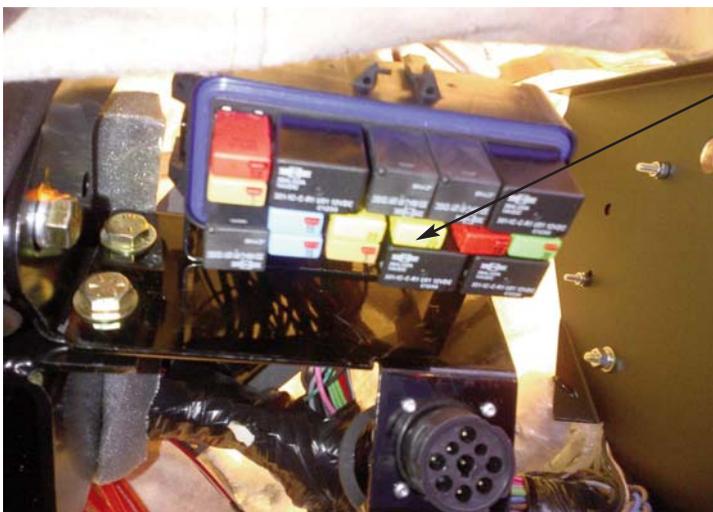
1. First chock the wheels and make sure the key is in the off position and you have the bus in neutral (Park) with the parking brake set.
2. Breaker for the Headlamps is under the dash at the driver's area near the steering column. Locate and remove the cover for the breaker. (PDM D)
3. Locate the breaker identified in the picture. **(Figure 1)**
 - 3.1 If it is a 20A (yellow breaker) then it has the incorrect breaker size installed.
 - 3.2 If it is a 30A type I breaker then no replacement is necessary.
 - 3.3 If the lights are still opening breaker there is another cause and you may stop at this step.
4. Remove 20A breaker.

LOCATION OF BREAKER.
REPLACE WITH 30A BREAKER.
