### **2016 Four-Hour Update**

# Inspector Instructor Update 2016

School Bus Entrance Doors

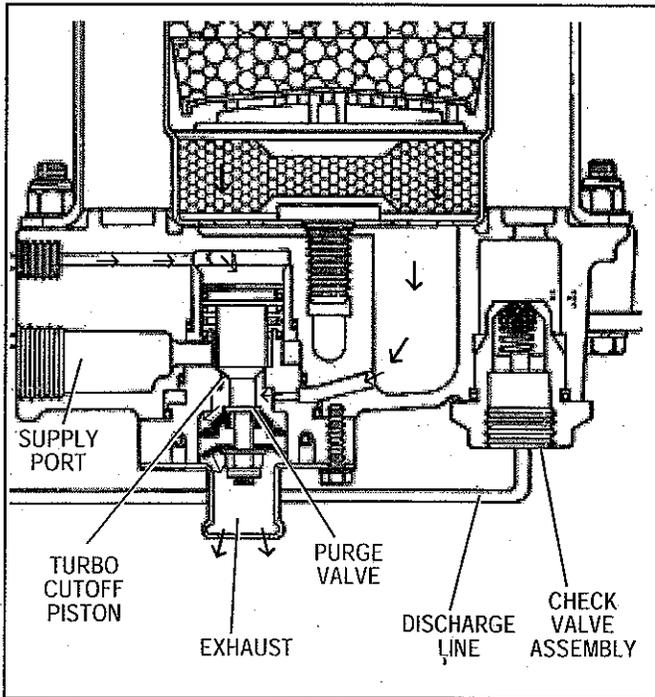
FIGURE 4 - AD-9™ AIR DRYER TURBO CUTOFF

At the onset of the purge cycle, the downward travel of the purge piston is stopped when the turbo cut-off valve (tapered portion of purge piston) contacts its mating metal seat in the purge valve housing. With the turbo cut-off valve seated (closed position), air in the discharge line and AD-9™ air dryer inlet port is restricted from entering the air dryer. While the turbo cut-off effectively prevents loss of turbo charger boost pressure to the engine, some "seepage" of air may be detected under certain conditions of compressor engine and turbo charger operation, even so there will always be low pressure trapped in the discharge line.

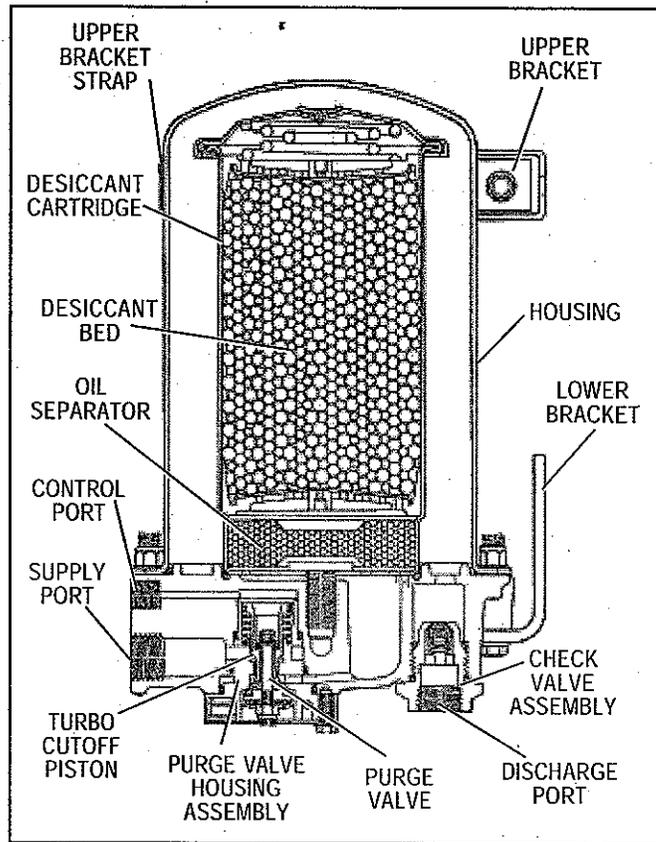
FIGURE 5 - AD-9™ AIR DRYER SECTIONAL VIEW

1. Check for moisture in the air brake system by opening reservoirs, drain cocks, or valves and checking for presence of water. If moisture is present, the desiccant may require replacement; however, the following conditions can also cause water accumulation and should be considered before replacing the desiccant:

- A. An outside air source has been used to charge the system. This air did not pass through the drying bed.
- B. Air usage is exceptionally high and not normal for a highway vehicle. This may be due to accessory air demands or some unusual air requirement that does not allow the compressor to load and unload (compressing and non-compressing cycle) in a normal fashion. Check for high air system leakage. If the vehicle vocation has changed it may be necessary to upgrade the compressor size. Refer to Appendix A, Table A and the column entitled Vehicle Vocation.

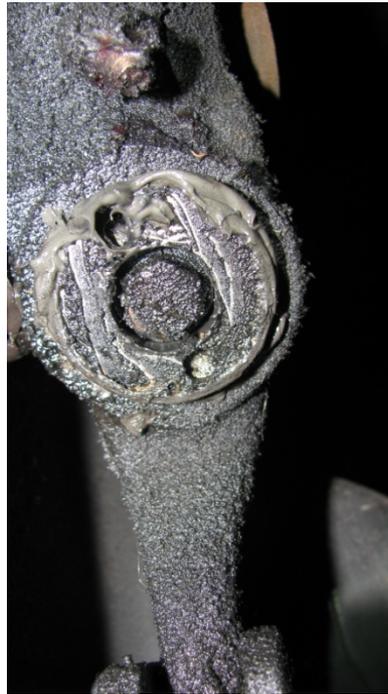
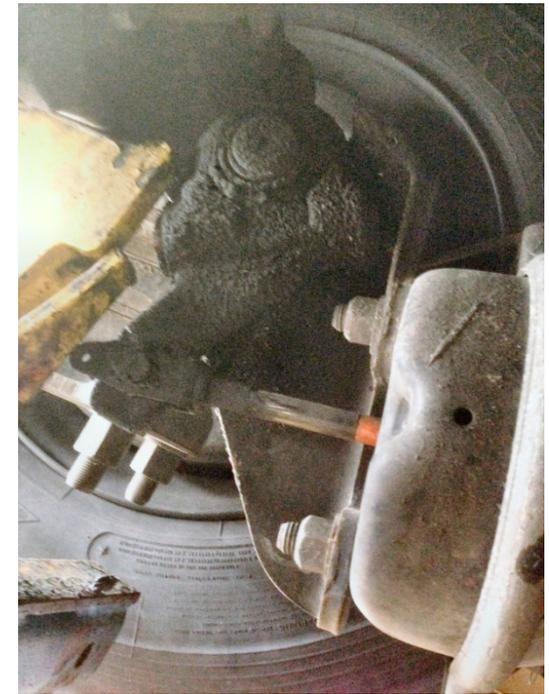
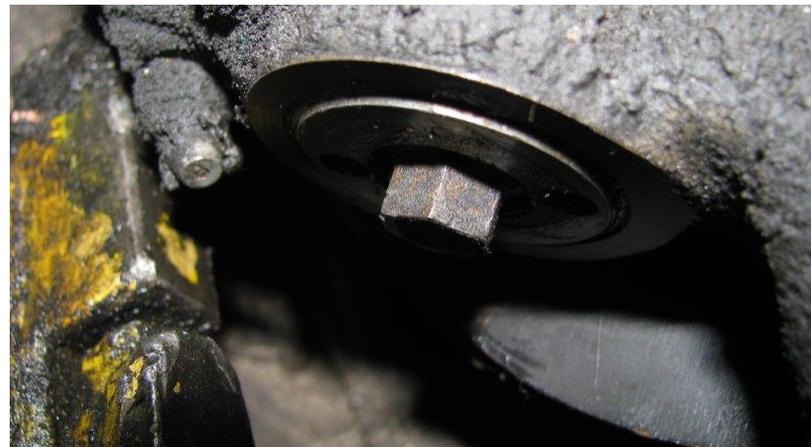
# HalDEX S-ABA Issues

- The retainer around the adjustment hex is unscrewing itself causing the brake adjustment not to hold.
- The brake chamber will eventually continue to maximum stroke and bottom out. Therefore resulting in no brakes on that wheel or wheels effected.
- A majority of the failed slack adjusters are on the rear, but a small percentage are on the front.

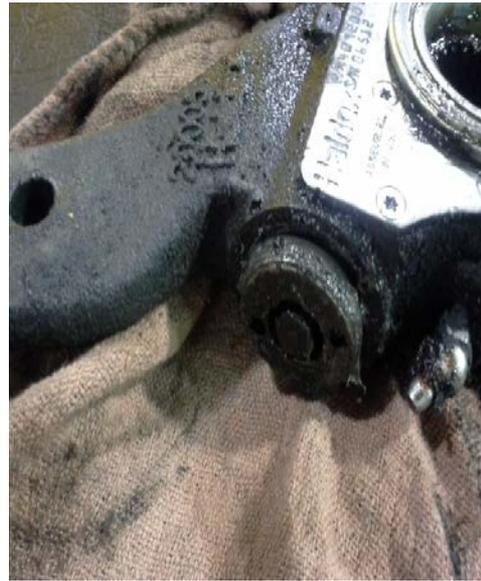
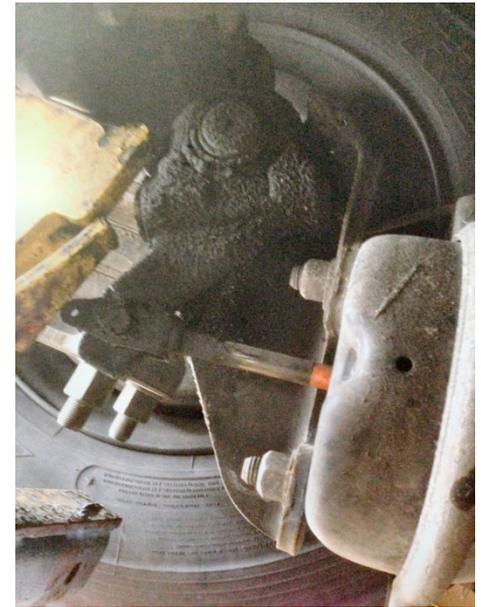
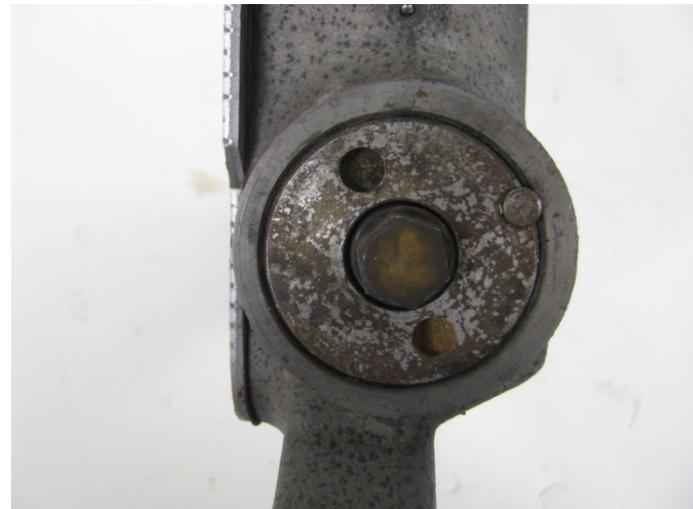
# Haldex S-ABA Issues

- Models effected 2011-13 Thomas/ Freightliner C2 52-66 Passenger buses.
- No reports have been made that IC or Bluebird buses have this issue.
- No formal recalls or bulletins have been put out by Haldex.
- No mileage range on when this slack adjuster may fail.
- A possible toque & securing process of the hex retainer has changed from being pinned to a thread locking compound.

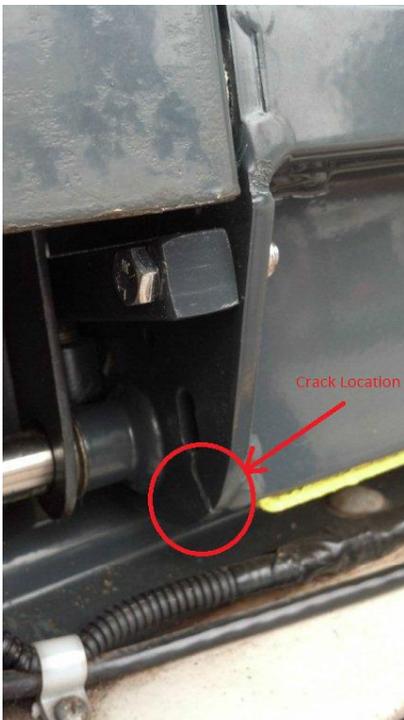
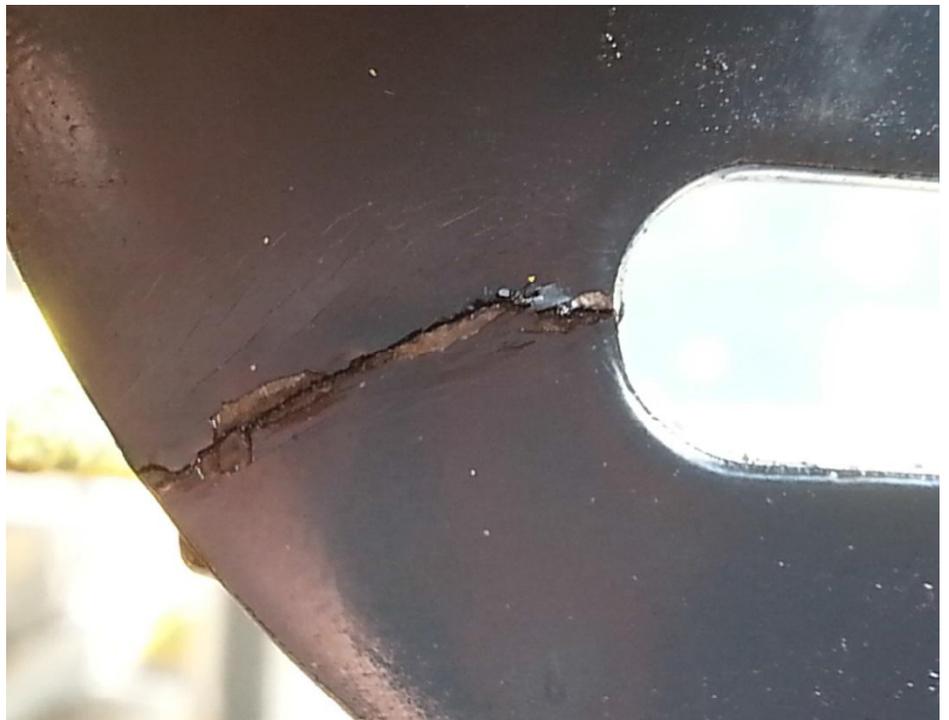
Under certain conditions the side plate of the larger platforms included on the subject S-Series model wheelchair lifts can exhibit cracking while in the stowed position which, if left unchecked can propagate to the point where separation of the rear portion of the side plate occurs rendering the lift inoperable and possibly unsafe to use.
