Agenda

2014 Four Hour Update

Fleet Condition Notes 2014

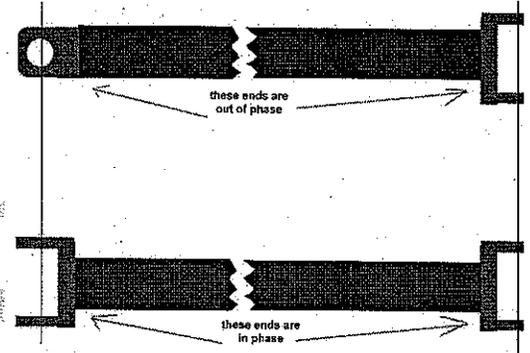
Visually inspect driveshaft for proper phasing. (see illustration)

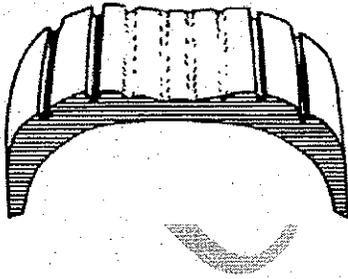
Over Inflation

Excessive wear at the center of the tread indicates that the air pressure in the tire is consistently too high. The tire is riding on the center of the tread and wearing it prematurely. Many times, this visual method of inflation (inflating the tires up until there is no bulge at the bottom) is at fault; tire inflation pressure should always be checked with a reliable tire pressure gauge.

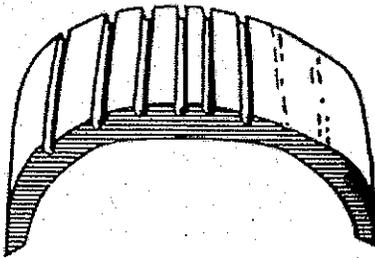
Side Wear

When an inner or outer rib wears faster than the rest of the tire, the need for alignment is indicated. There is excessive camber in the front suspension, causing the wheel to lean too much to the inside or outside and putting too much load on one side of the tire. Misalignment could be due to sagging springs, worn ball joints, worn control arm bushings, or worn king pin bushings.

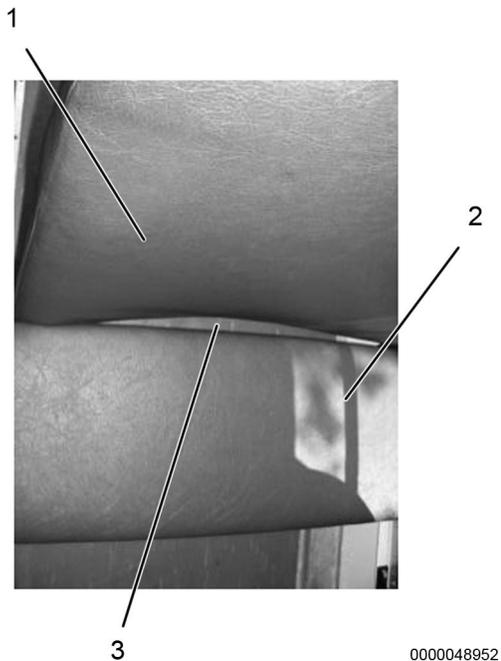
Figure 1. Bow in Seat Back.

1. Seat back
2. Seat cushion
3. Bowing

6. Unsnap j-clip, loosen foam from frame, and slide off upholstery and foam as assembly.
7. Install and latch seat cushion (Figure 1, Item 2) of each seat back (Figure 1, Item 1) needing repair and place upholstery and foam assembly on floor in front of seat.

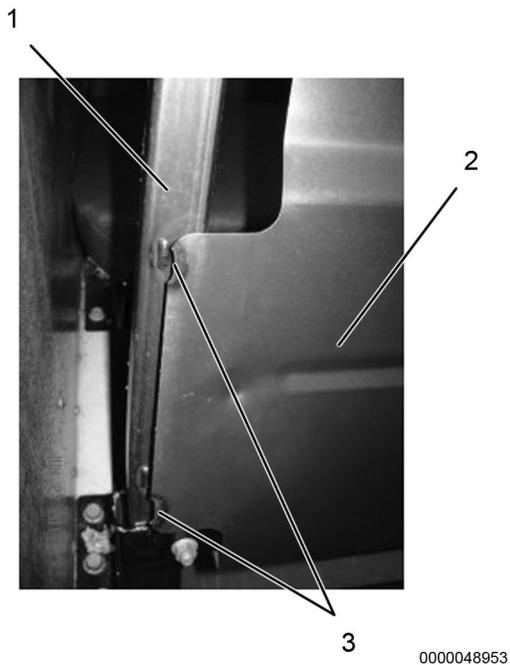
Figure 2. Back Pan Welds.

1. Back pan frame
 2. Back pan
 3. Weld
8. Inspect welds (Figure 2, Item 3) on back pan (Figure 2, Item 2) and back pan frame (Figure 2, Item 1) to confirm back pan failure. If no weld failure is found, reinstall upholstery and foam assembly and snap j-clip

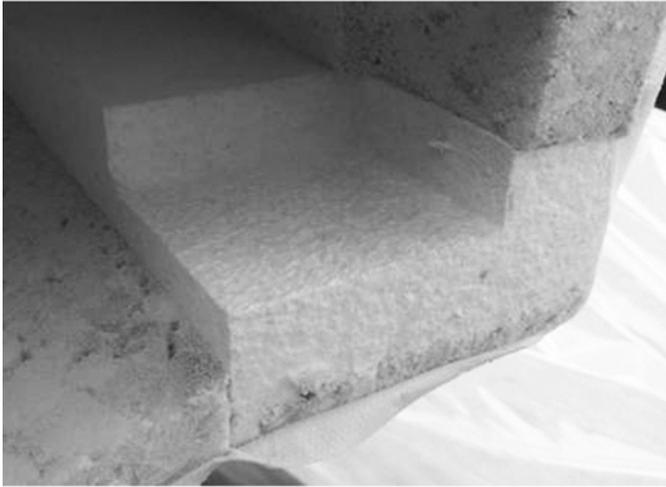
Figure 3. Replaced Seat Back Foam.

- a. Replaced seat back foam has a smooth square cut notch at affected area (Figure 3). No inserts are necessary. Proceed to Step 11.

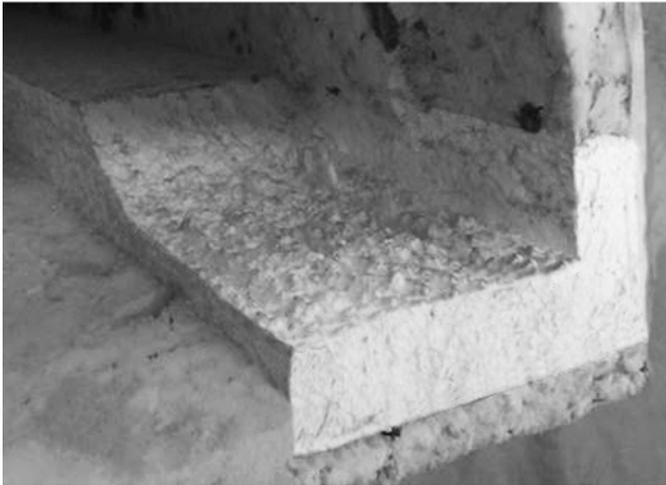
Figure 4. Original Seat Back Foam.

- b. Original seat back foam has a coarse bevel gut notch in affected area (Figure 4). Foam inserts must be installed. Proceed to Step 7.

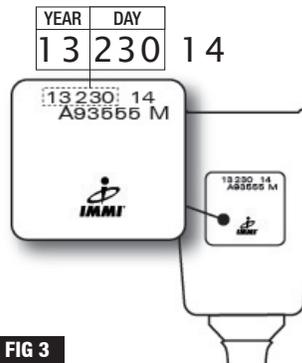
FIG 3

Suspect code range is
13220 through 13256

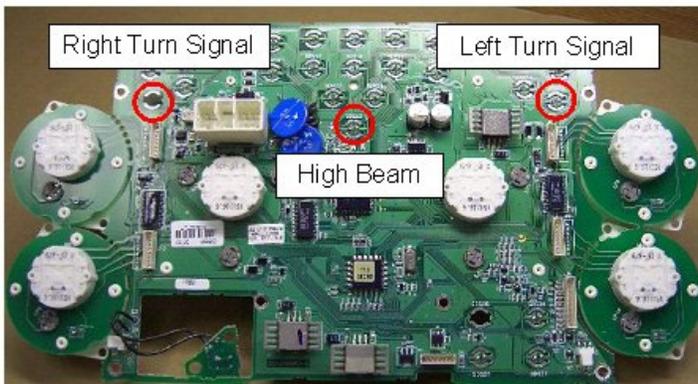
7. Determine the location of the LED needing replacement. Figure 6 shows the backside of the circuit board with red circles around the right and left turn signals, and the hi beam headlight indicators.

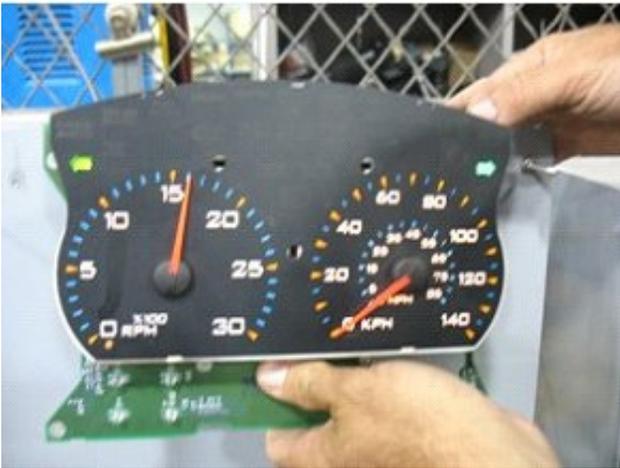
Figure 10

NOTE – The color of the replacement LED will be a yellowish green as apposed to the dark green of the original turn indicator-see Figure 10. For uniform appearance at minimal cost, replace both left and right turn indicators at the same time while the back of the board is accessible.

10. Insert the replacement LED into the mounting hole. Place the wider tab as shown in Figure 9 toward the right side of the mounting hole as viewed from rear of the printed circuit board. Insert a small flat bladed screw driver into the LED base and rotate it clockwise until the stop is felt (approx. 30°). See Figure 11. If the replacement LED is placed into the hole with the larger lug on the left side, it will not illuminate. LED's must have the proper polarity to function properly.

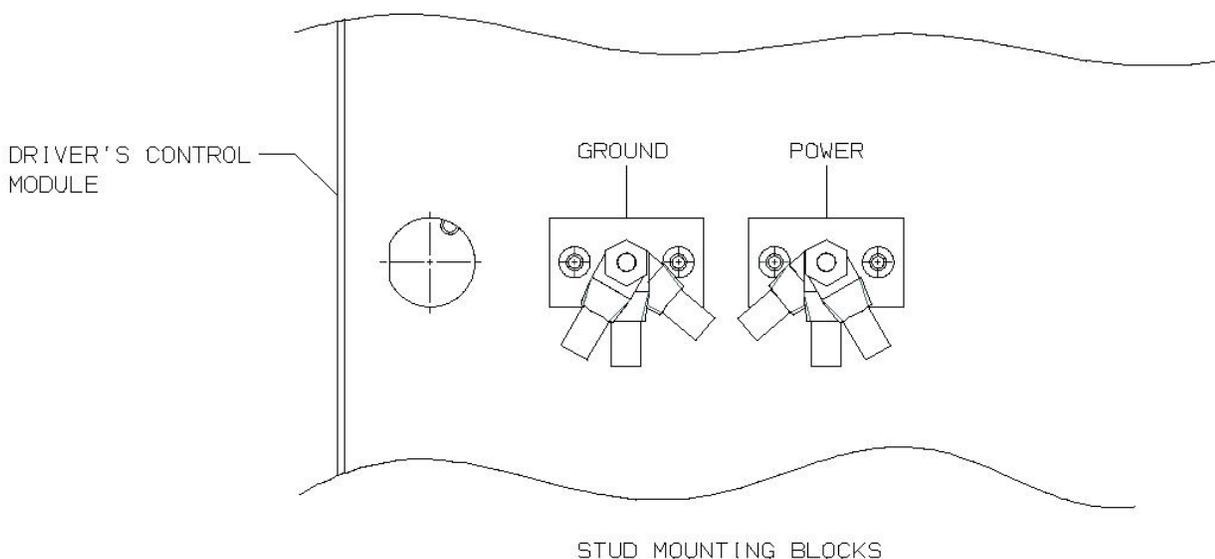
1. Park the vehicle on a level surface, apply parking brake, turn engine off, remove ignition key and chock wheels.
2. Disconnect batteries. *Always remove negative cables first.*
3. Open engine hood and locate the Chassis Power Stud(s) on the driver's side of the **Driver's Control Module (DCM)**. Depending on the type of engine installed and options on the vehicle (air conditioning and/or lift), there could be one or two power studs next to the Ground Stud. See the following diagrams.

Incorrect Power Cable Lug Orientation

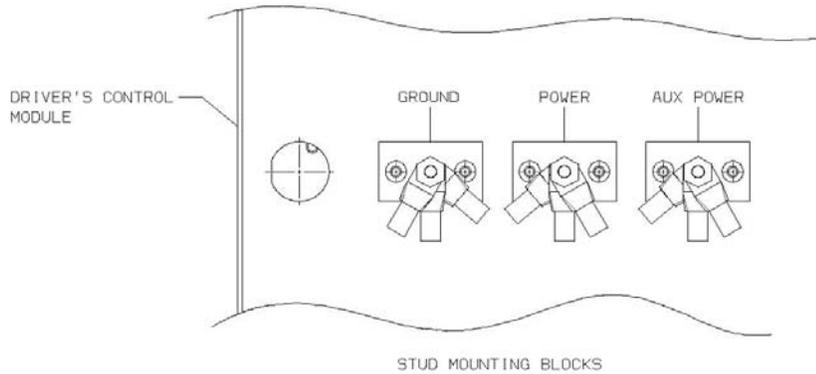
4. Inspect the electrical cable connections at the Power Stud and Aux Power Stud, if installed. See the diagram below to determine if the cables were installed correctly. ALL terminal lugs on each power stud should be oriented such that the barrel of the lug is further away from the mounting surface of the isolated stud. The flat side of terminal end (lug) must be down.

5. If the cables were installed incorrectly, remove the nut securing the cables. Then remove the cables and reinstall correctly per the diagram above. Make sure the terminal lugs are fanned out on the stud as opposed to directly on top of each other. Vice-grip pliers are recommended when turning incorrectly installed cable terminal lug to the correct orientation of flat side down.

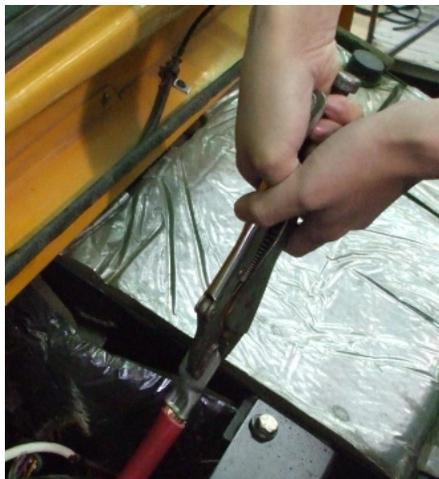
Caution: Do not grasp cable on insulation

6. Secure the cables with the nut and torque to 12 to 15 ft-lbs.
7. Apply corrosion resistant coating (glyptal) as required to prevent corrosion.

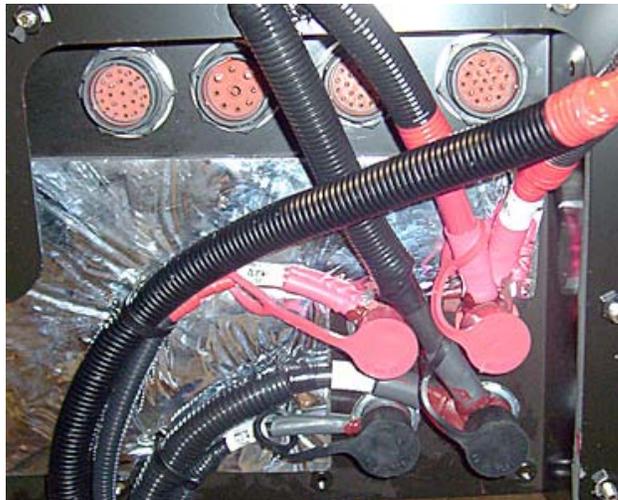
9. Next, locate and inspect the two Power Studs below the 4 Deutsch connectors.

10. Remove the two red protective covers and inspect the electrical cable connections at the Power Studs.

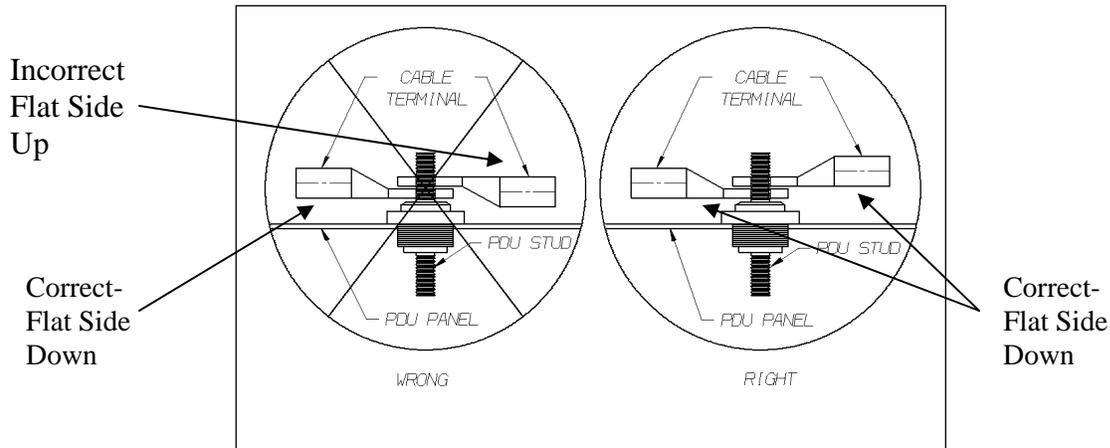
Incorrect Power Cable Lug Orientation

11. Remove the nut securing the cables. Then remove the incorrectly installed cables and reinstall correctly with flat side down. Make sure the terminal lugs are fanned out on the stud as oppose to directly on top of each other.
12. If needed, use vise grips to rotate cable so lug fits with flat side down. See photo on page 2.
13. Secure the cables with the nut and torque to 12 to 15 ft-lbs.
14. Apply corrosion resistant coating (glyptal) as required to prevent corrosion.
15. Reinstall the red protective covers.
16. While having access to this area, inspect ALL power cables for any evidence of contact with the rear of the engine, chaffing, or other damage. **Ensure clearance between power cables and any part of the engine is more than ½ inch.**

If any damaged cables are found, contact Blue Bird Recall Administration for replacement cable(s).

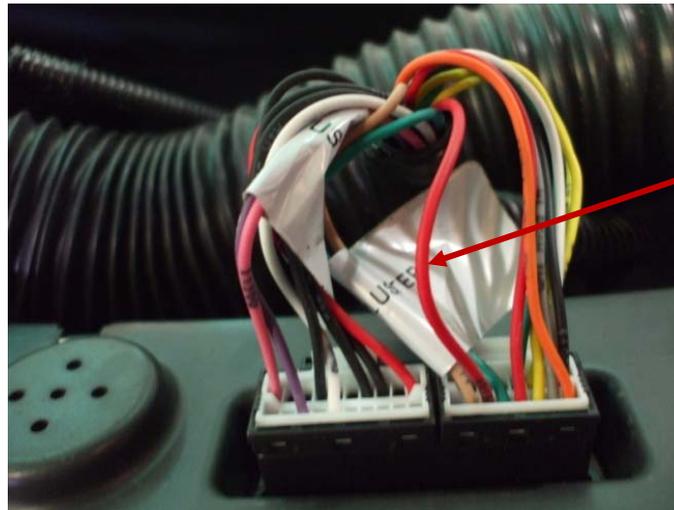
Step 5. Locate Red wire labeled “STOP LGT A”. Wire is in location as shown in Picture 4 above.

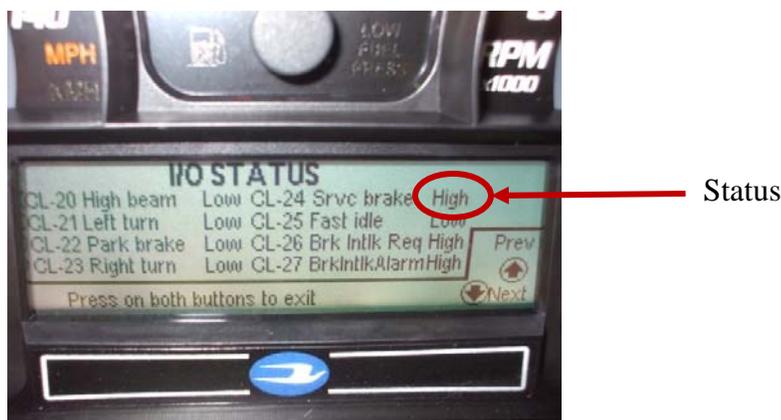
Picture 5

At this point note the status should be displayed as "CL-24 Srvc brake High" when the brake pedal is NOT pressed.

Step 7. Press both buttons simultaneously to enter into the I/O STATUS menu. See Picture 5. Using the bottom button, scroll through the menus until you come to CL-24 Srvc brake. This is shown in picture 5.

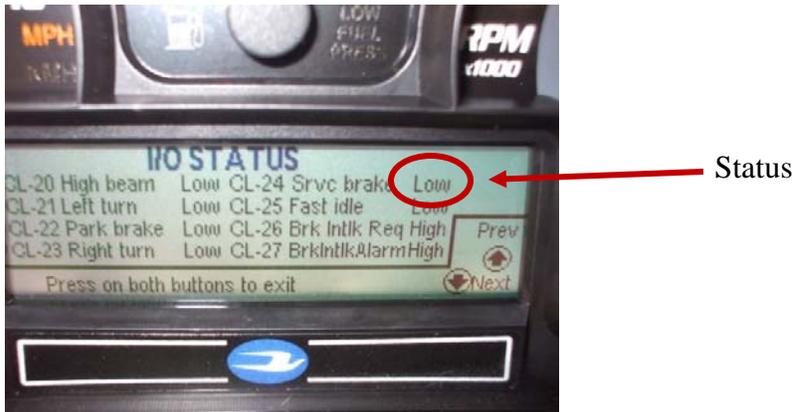
Picture 6

If the display changed from High to Low, the cluster is receiving a brake switch status and verification is complete.

Step 8. Press the brake pedal firmly and note the status of CL-24. It should have changed to:
“CL-24 Srvc brake Low”. See picture 6

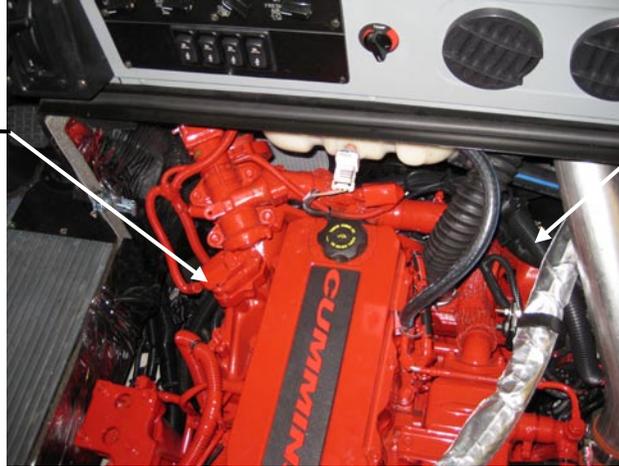
The ¼” serrated flange head nuts that secures the starter cable and engine wiring harness to the mounting brackets located on the front of the engine may become loose and fall off allowing the cable and harness to contact engine fan drive belt or the fan clutch assembly.

- 5 Inspect the starter cable and wiring harness from the right side of the engine, across front of engine to left side of engine for any chaffing, rubbing or damage. If starter cable and wiring harness shows any evidence of damage, contact Blue Bird Recall Administration.

- 6 One starter cable and wiring harness support is located on the right side of the engine between the alternator and engine fan.
- 7 Remove and discard the ¼" serrated nut (and flat washer if installed). Install the new ¼" locknut (0145847) and flat washer (01247709) provided. Torque nut to 60-85 in. lbs. Note: two complete threads must extend completely through the nut.

Replace with new locknut and flat washer (Note: new locknut shown)

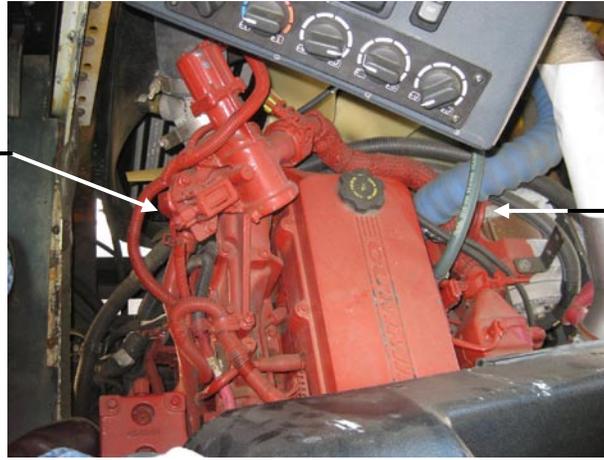
3. Inspect the starter cable and wiring harness from the right side of engine, across front of engine to left side of engine for any chaffing, rubbing or damage. If starter cable and wiring harness shows any evidence of damage, contact Blue Bird Recall Administration.

- 4 One starter cable and wiring harness support is located on the right side of the engine between the alternator and engine fan.
5. Remove and discard the 1/4" serrated nut (and flat washer if installed). Install the new 1/4" locknut (0145847) and flat washer (01247709) provided. Torque nut to 60-85 in. lbs. Note: two complete threads must extend completely through the nut.

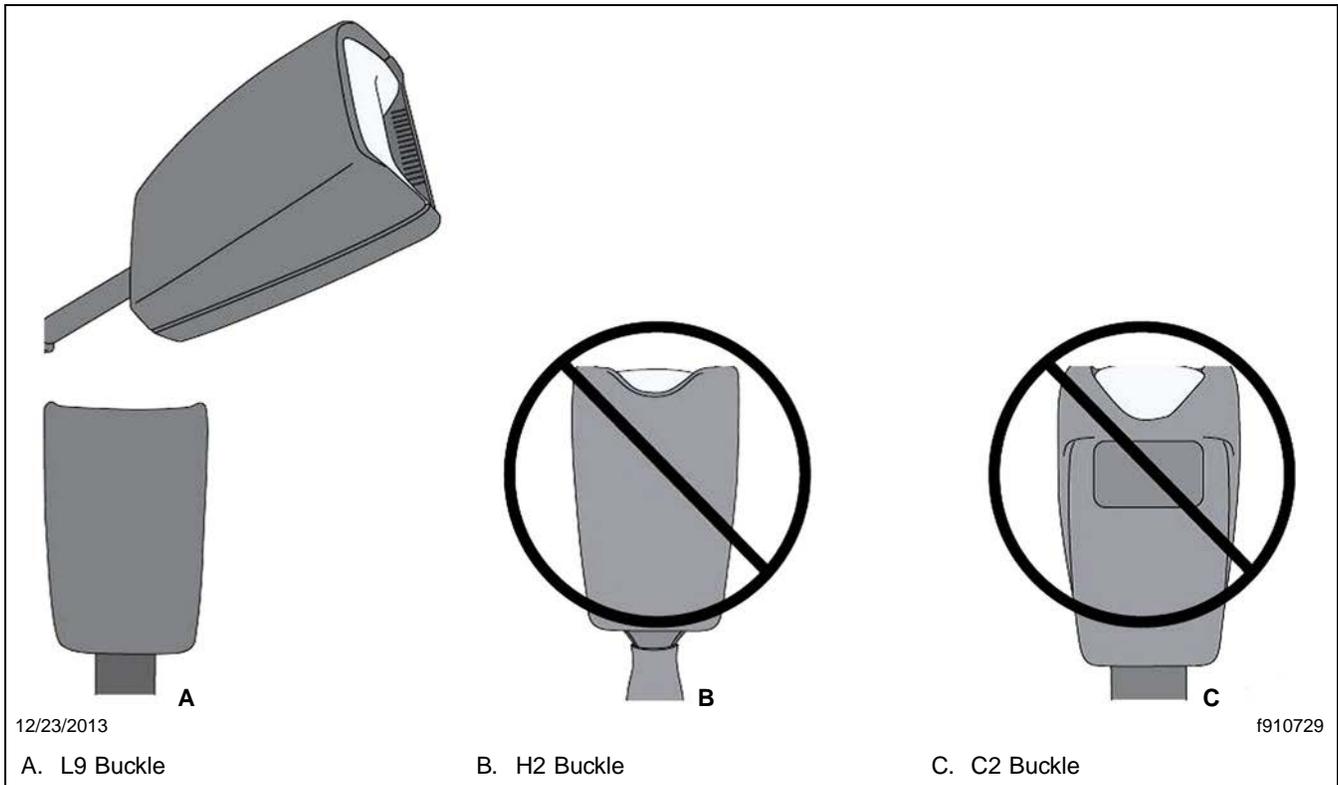
Fig. 2, IMMI L9 Buckle Identification

4. Verify that the buckle is an IMMI L9 buckle. Only IMMI L9 buckles are affected by this recall. See **Fig. 2**.
5. If the buckle is an IMMI L9 buckle, check the back of the housing for the date code. See **Fig. 3**.
If the date code is included in the ranges shown in **Fig. 3**, the buckle needs to be replaced. If the date code is outside these ranges, the buckle does not need to be replaced.
6. If the vehicle has buckles that need to be replaced, go to "Buckle Replacement – School Buses" or "Buckle Replacement – Trucks" as appropriate in these Work Instructions.
If no buckles need to be replaced, clean a spot on the base label (Form WAR259), write the recall number, FL654, on a blank red completion sticker (Form WAR260), and attach it to the base label.

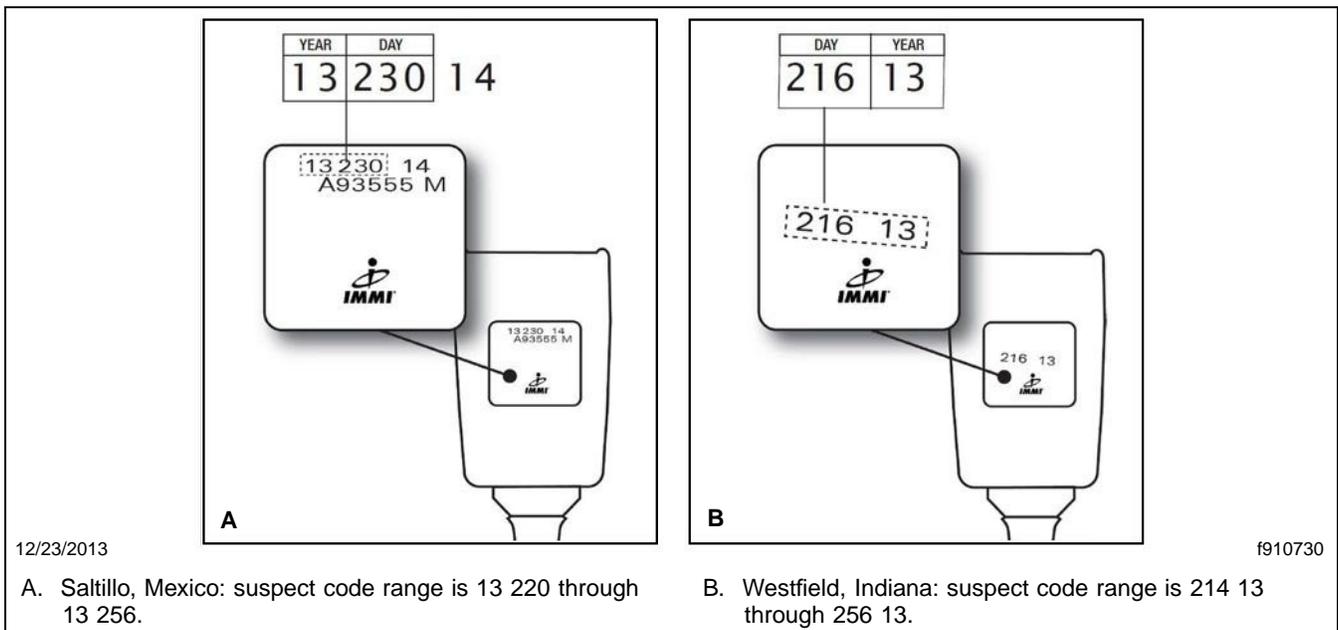
Fig. 3, Buckle Date Code Ranges

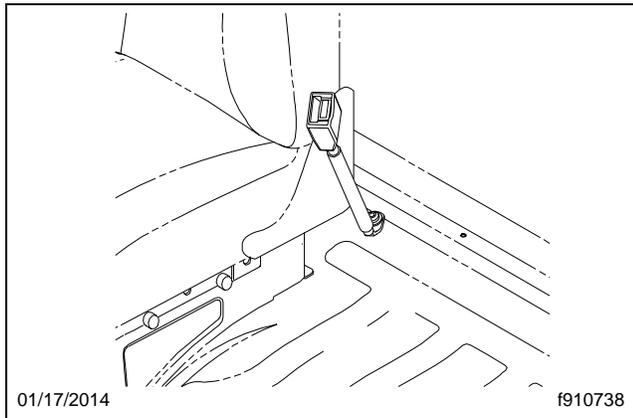
Fig. 10, Floor-Mounted Buckle

1. Remove the capscrew that attaches the buckle to the cab deck. See **Fig. 10**. Remove and discard the buckle.
2. Attach the new buckle to the cab deck. Tighten the capscrew 35 to 45 lbf·ft (48 to 61 N·m).

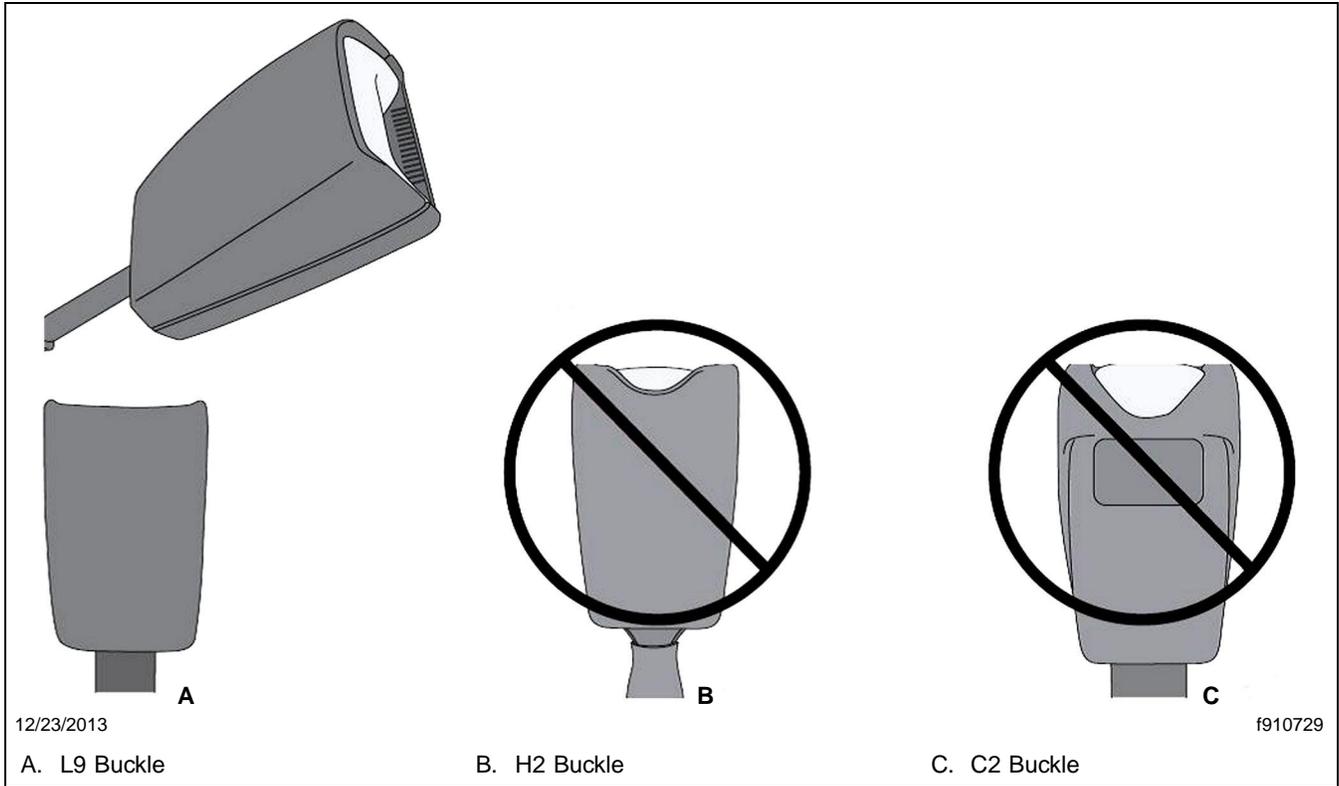
Fig. 2, IMMI L9 Buckle Identification

4. Verify that the buckle is an IMMI L9 buckle. Only IMMI L9 buckles are affected by this recall. See **Fig. 2**.
5. If the buckle is an IMMI L9 buckle, check the back of the housing for the date code. See **Fig. 3**.
If the date code is included in the ranges shown in **Fig. 3**, the buckle needs to be replaced. If the date code is outside these ranges, the buckle does not need to be replaced.
6. If the vehicle has buckles that need to be replaced, go to "Buckle Replacement – School Buses" or "Buckle Replacement – Trucks" as appropriate in these Work Instructions.
If no buckles need to be replaced, clean a spot on the base label (Form WAR259), write the recall number, FL654, on a blank red completion sticker (Form WAR260), and attach it to the base label.

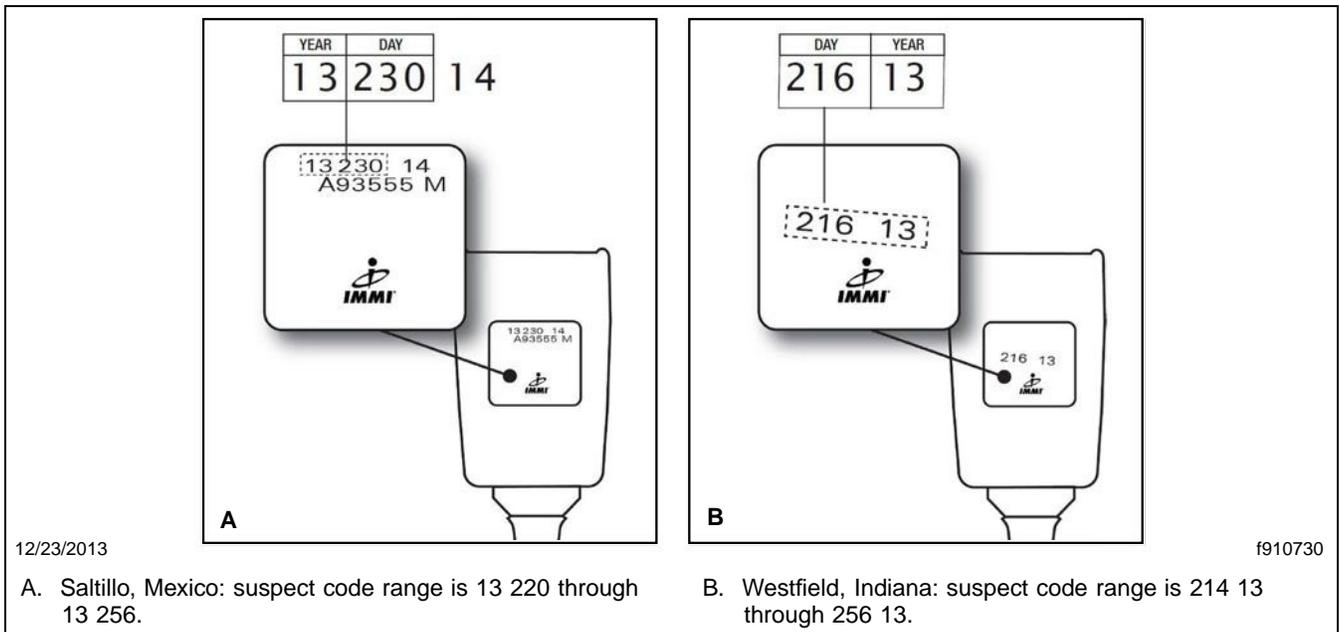
Fig. 3, Buckle Date Code Ranges

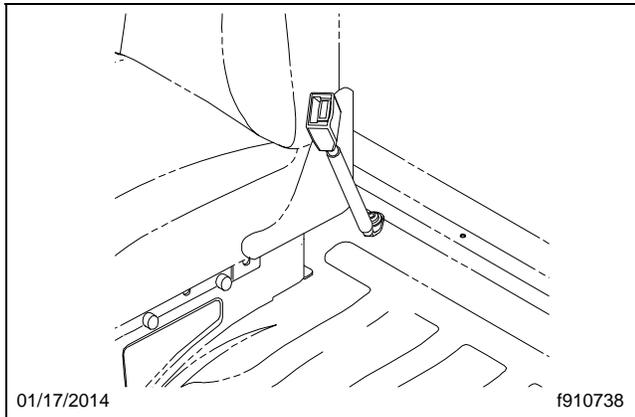
Fig. 10, Floor-Mounted Buckle

1. Remove the capscrew that attaches the buckle to the cab deck. See **Fig. 10**. Remove and discard the buckle.
2. Attach the new buckle to the cab deck. Tighten the capscrew 35 to 45 lbf-ft (48 to 61 N·m).
