### **2016 Four-Hour Update**

# Inspector Instructor Update 2016

School Bus Entrance Doors

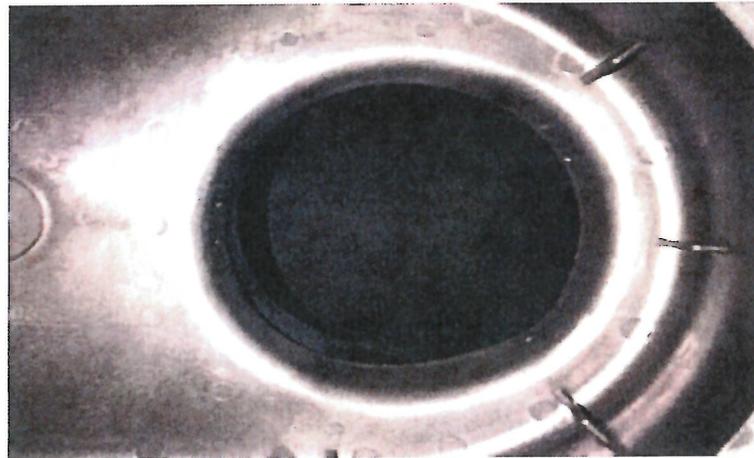
Figure 2

- 4) Take the filter out and keep for reinstallation.
- 5) Once the filter is removed, inspect the inside of the two tubes that are the entrance and exit of the housing. The inside circumference should not have any indentions or flattened edges (**Figure 2**).

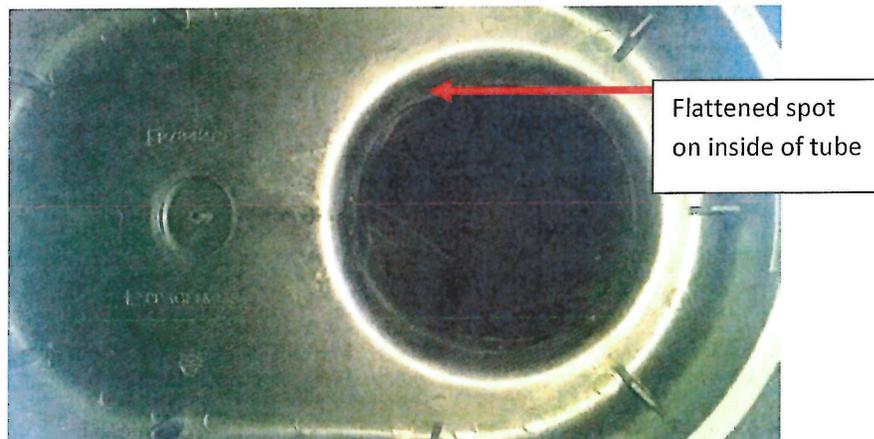
Figure 3

If the interior where the module clamps to the hose has a flat spot or indentation, replace the housing. (**Figure 3**)

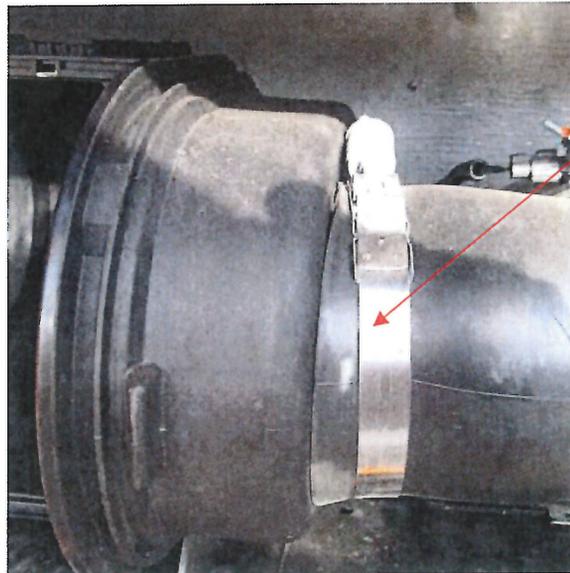
Figure 4

- 1) Loosen the two clamps on each side of the air cleaner housing.
- 2) Pull the hose out of each side and insert the new module and hoses.
- 3) Make sure that the metal clamps that hold the module on each end are parallel to the entrance. If the straps are like the one shown in **Figure 4**, correct the strap so that it is not at an angle.
- 4) Tighten the straps to 40 lbf·in (452 N·cm).
- 5) Un-chock tires.

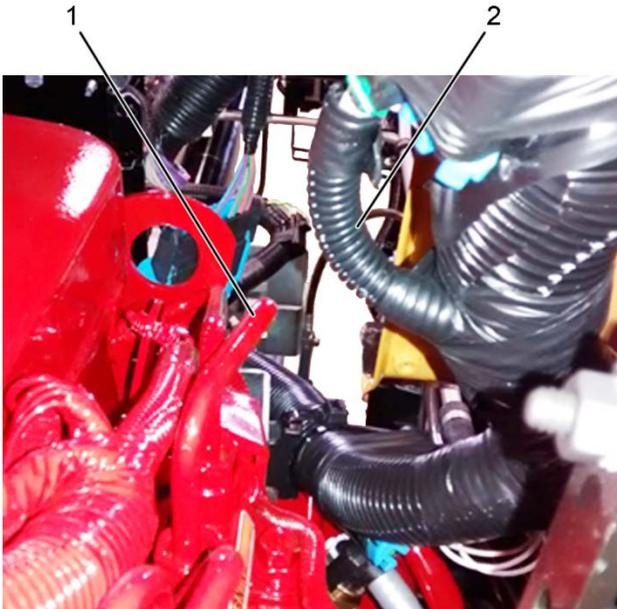
**Figure 2. High-Pressure Fuel Line.**

1. Injector 5 high-pressure fuel line
2. Powertrain harness

8. Lift powertrain harness (Figure 2, Item 2) to provide minimum 1 in clearance with high-pressure fuel line to number 5 injector (Figure 2, Item 1) and tighten cable tie strap (Figure 1, Item 6). Cut off extra cable tie strap end and discard.

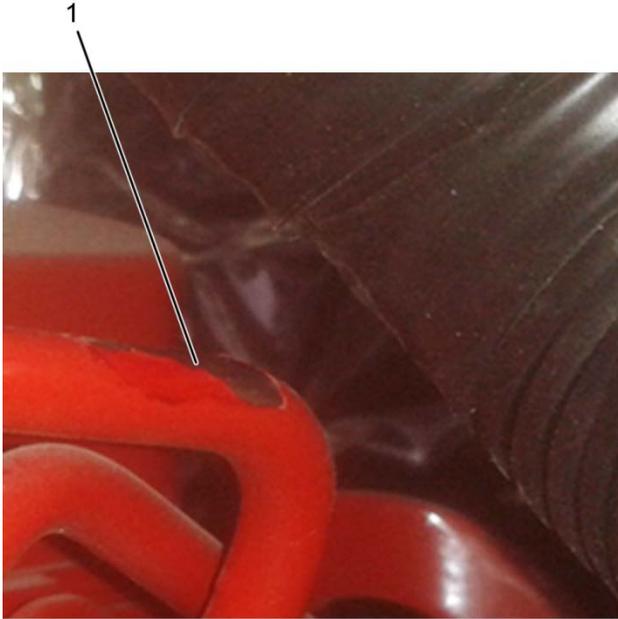
**Figure 3. Paint Abrasion.**

1. Paint abrasion, injector 5 high-pressure fuel line
9. Inspect injector 5 high-pressure fuel line for paint worn off from abrasion (Figure 3, Item 1).
    - a. If **ONLY** paint is worn from abrasion, properly clean area and protect with new paint.
    - b. If fuel line metal surface is worn from abrasion, take picture and open a technical service case file for approval to order from Cummins, part number 4935974, and replace fuel line according to Cummins replacement procedures. If a fleet is performing the inspection and a fuel line is required, contact your local dealer and have them submit the case file.
  10. Close and latch hood.
  11. Remove wheel chocks.

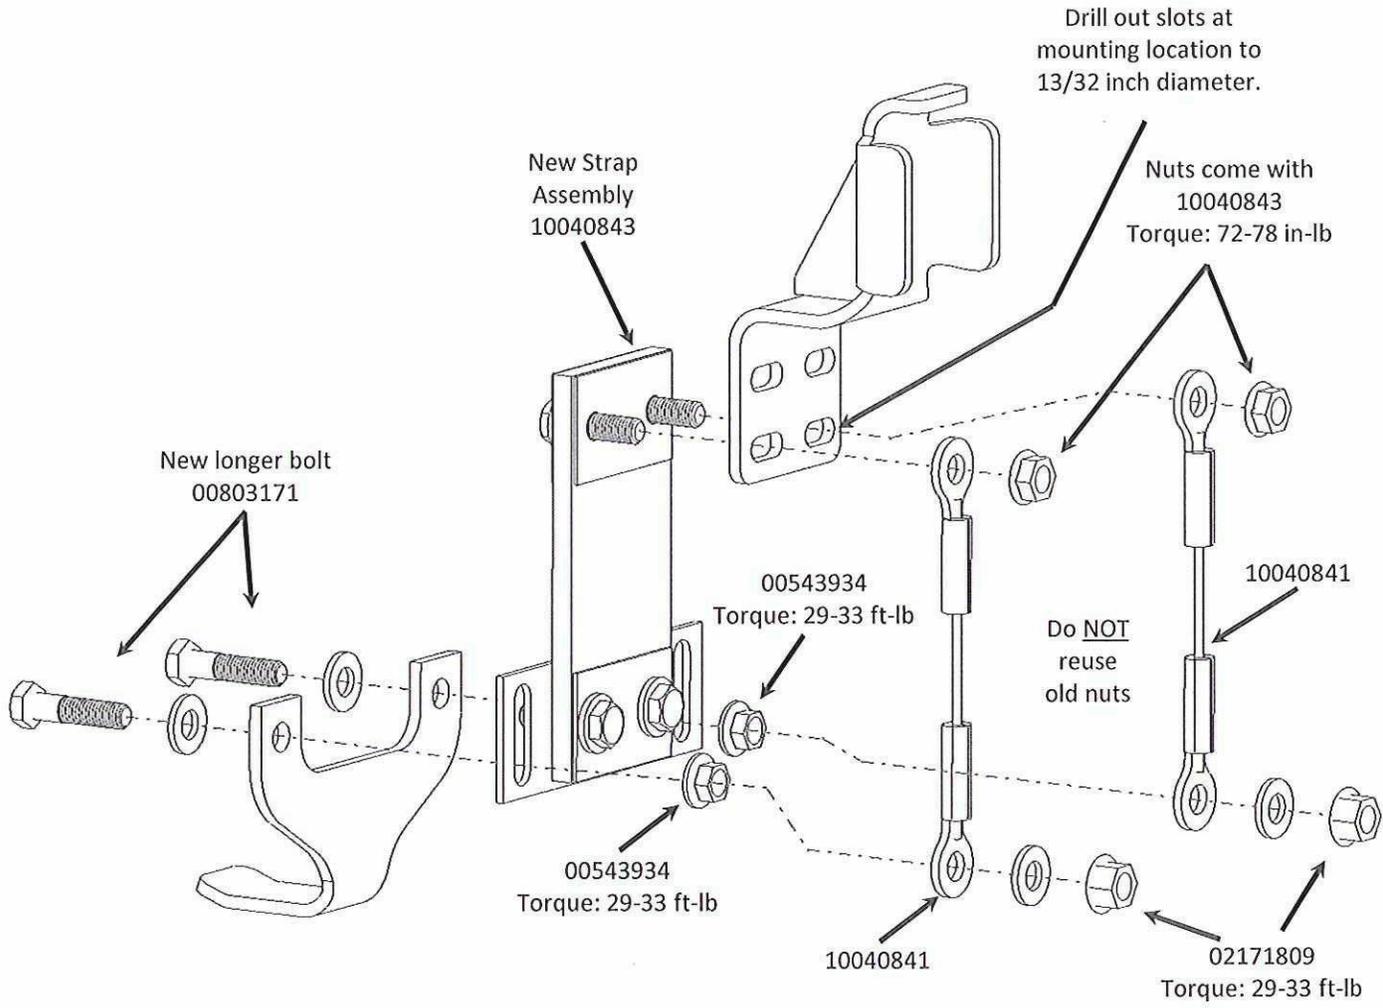
R I 5 Y B

Blue Bird Body Company has decided that a defect which relates to motor vehicle safety exists in certain 2011 through 2016 model year Blue Bird All American Rear Engine model school and non-school buses manufactured from June 5, 2010 through January 13, 2015, and equipped with optional Cummins diesel engines.

On the subject buses, the exhaust system hanger straps may fail under extreme conditions causing damage to the Selective Catalytic Reduction (SCR) and Diesel Particulate Filter (DPF) housings. This hanger failure may allow the exhaust system to partially or completely dislodge from some or all of its mounting points. If the housings were to fall onto the roadway, this could create a road hazard, increasing the risk of a crash. Blue Bird is conducting a recall to correct this defect.

To correct this defect, new exhaust hanger assemblies and exhaust support cables will be supplied to replace each of the four existing exhaust hanger assemblies.

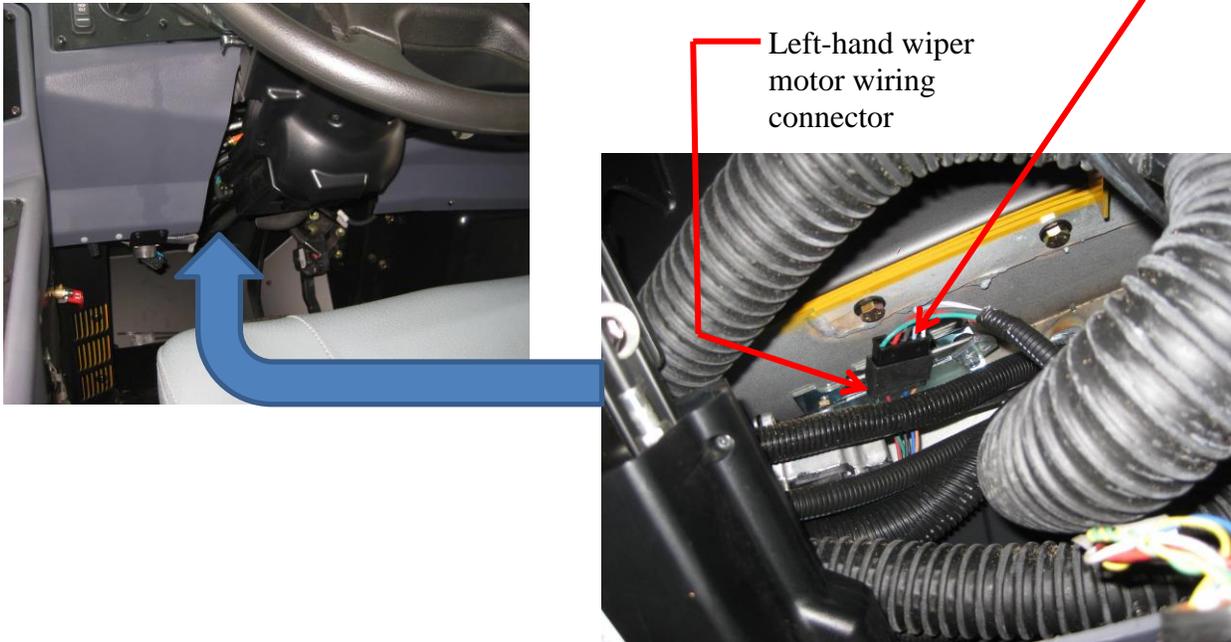
4. The left-hand wiper motor is located on the left-side of the steering column.

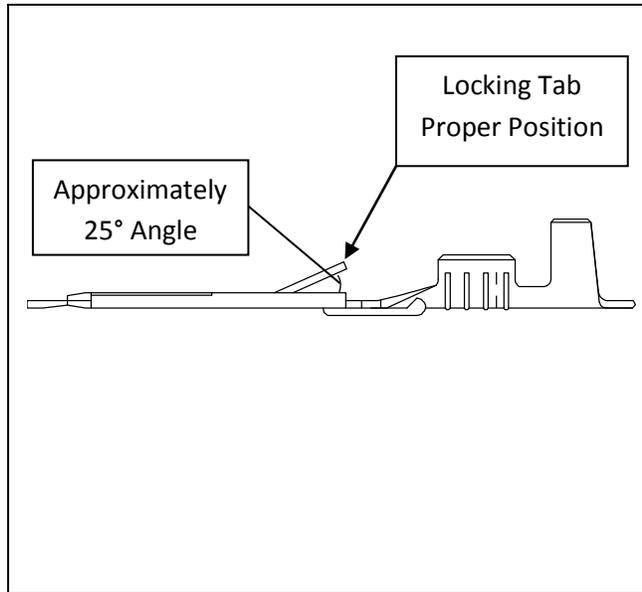
3. Examine each loose terminal for proper locking tab position, if the terminal does not match the picture shown perform step 4. If the terminal has the locking tab in the correct position move on to step 5.

4. Using the miniature screwdriver push the locking tab outwards until it matches the image shown in step 3.

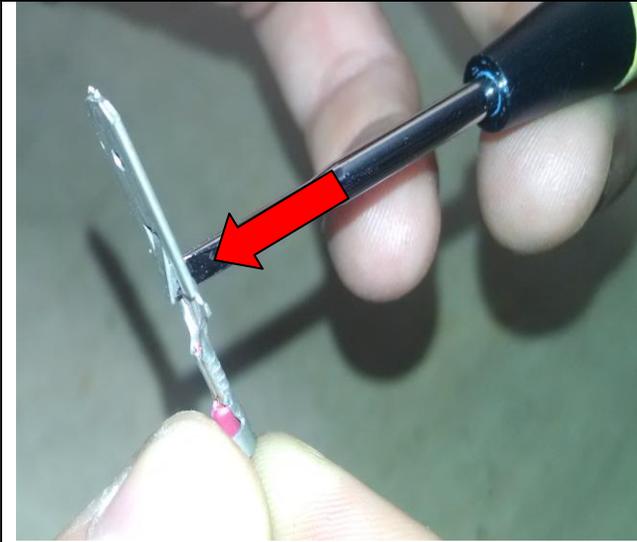
3. Examine each loose terminal for proper locking tab position. If the terminal does not match the picture shown move on to step 4. If the terminal has the locking tab in the correct position move on to step 5.

4. Using the miniature screwdriver push the locking tab outwards until it matches the image shown in step 3.

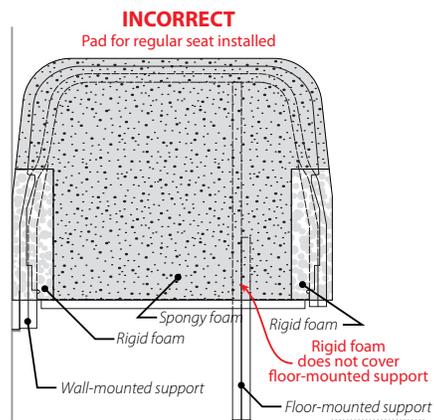
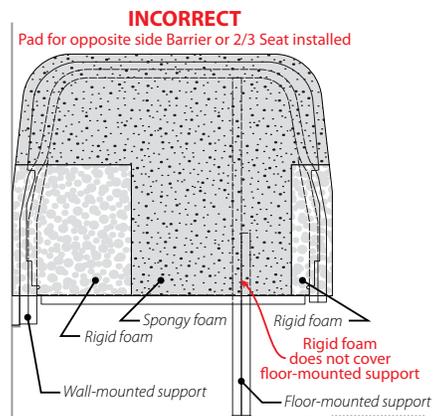
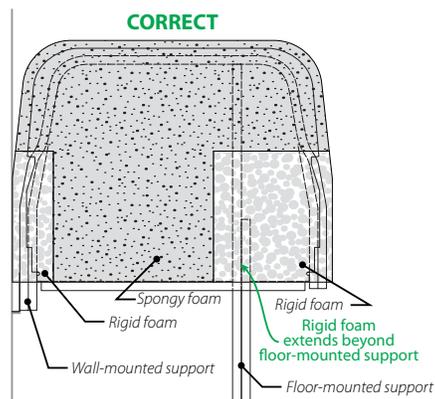
R09PM

- Correct Pads For Barrier and 2/3 Seat Backs. The offset support legs of Seat Barriers and 2/3 Seat Assemblies extend vertically inside the back frame. These vertical frame members are required to be covered by the rigid foam components of the Pad Assembly.
- Incorrect Pads For Barrier and 2/3 Seat Backs. If a Pad Assembly for a regular full-width seat is installed on a Barrier, or on a 2/3 Seat Back, the vertical extension of the support legs are not sufficiently covered by the rigid foam type.

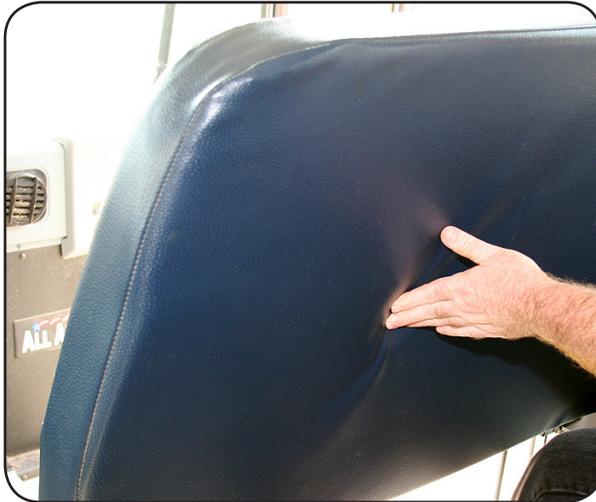
*The edge of the rigid foam inside the cover of a Barrier or a 2/3 Seat extends beyond the vertical support leg, which is offset from the aisle-side of the seat.*

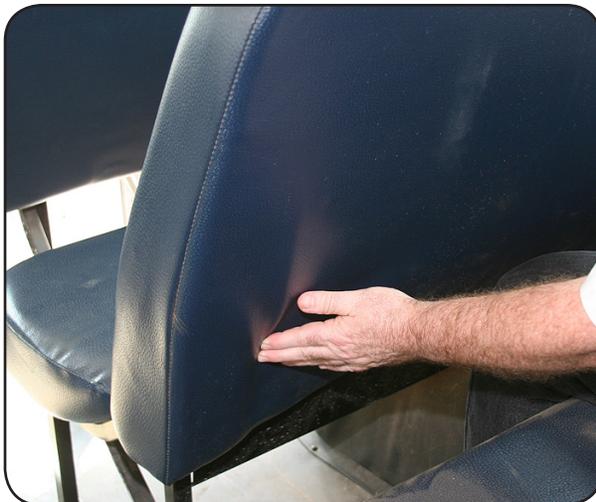
*The pad of a regular seat back also has rigid foam pieces, but they do not extend as far from the aisle-side of the seat, because the vertical support leg is not offset.*
